Contract No. CM 04/2024 - Outlying Islands Sewerage
Stage 2 – South Lantau Sewerage Works –
Environmental Team Services (2025 - 2027)

Final Investigation Report

Contract: DC2020 - Outlying Islands Sewerage Stage 2 – South Lantau Sewerage Works – Environmental Team Services (2025 - 2027)

ET Log Reference: 007

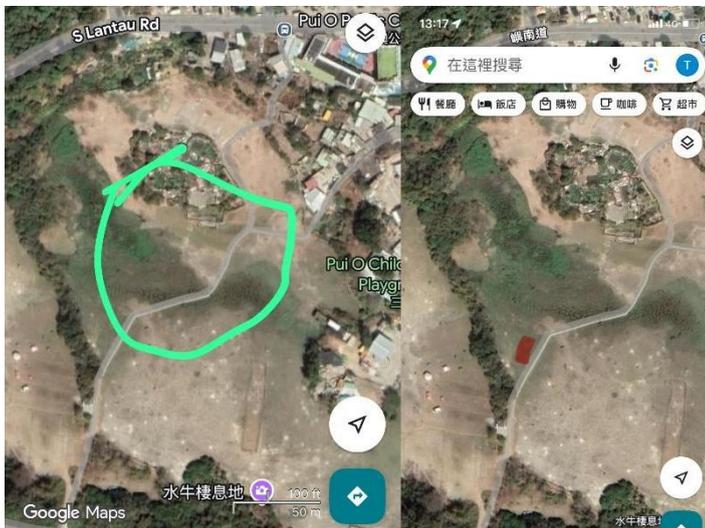
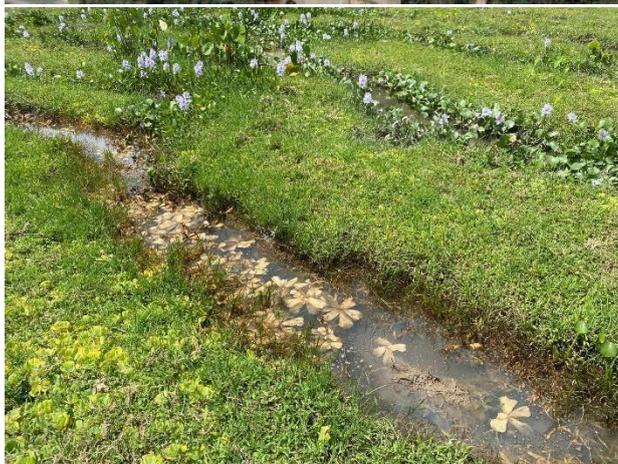
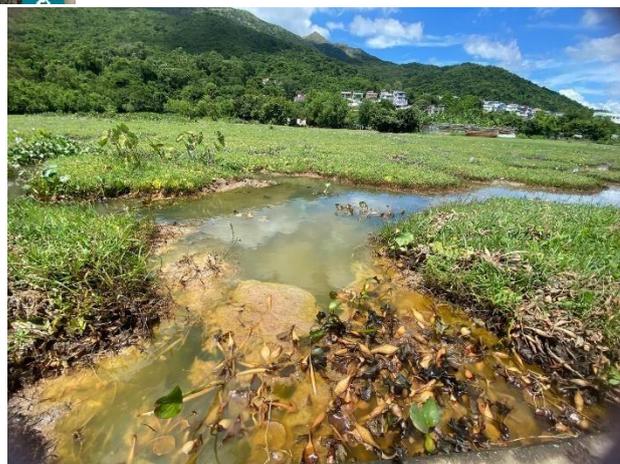
昨天收到貝澳居民投訴，指貝澳濕地（位置見圖）發現有電油，電油佈滿部份濕地的水及泥土中，導致部份浮籐及浮萍枯死。源頭不明。

今日中午時到過上址，發現在附地圖紅間位置濕地上的植物有枯萎情況，有村民表示今早仍見有油跡由西北方往東南流動。中午時，雖未見明顯油跡，但有強烈的氣油味從嶼南路方向飄來。再到嶼南路尋持氣油味的來源，似乎在羅屋村往東涌方向巴士站旁的垃圾站小徑中途發出，亦不排除與工程地盤有關。

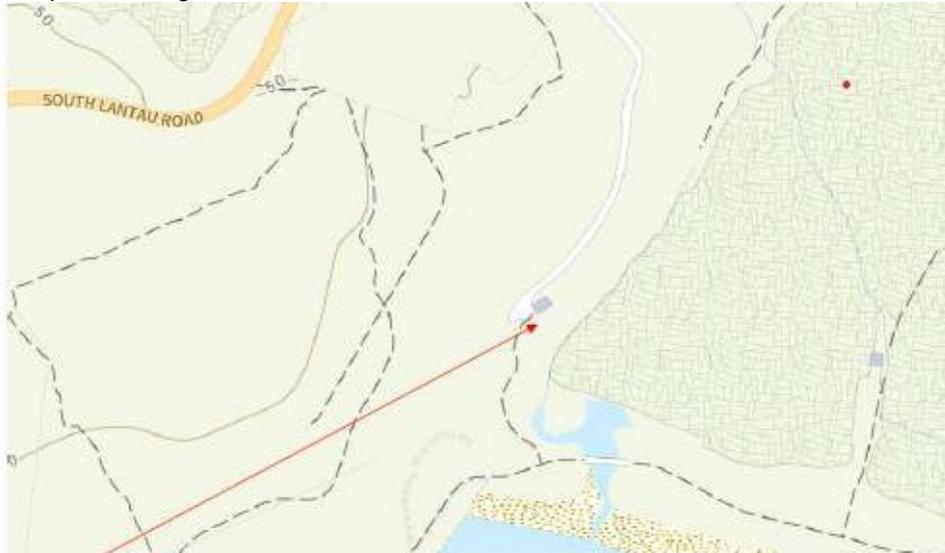
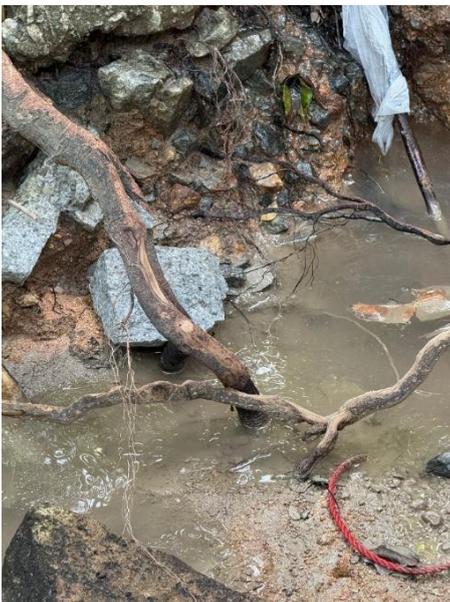
Location of oil signs

On 25 September 2025, additional information from EPD was received that oil signs spotted in the Pui O. Location map and relevant photos, are given as follows.

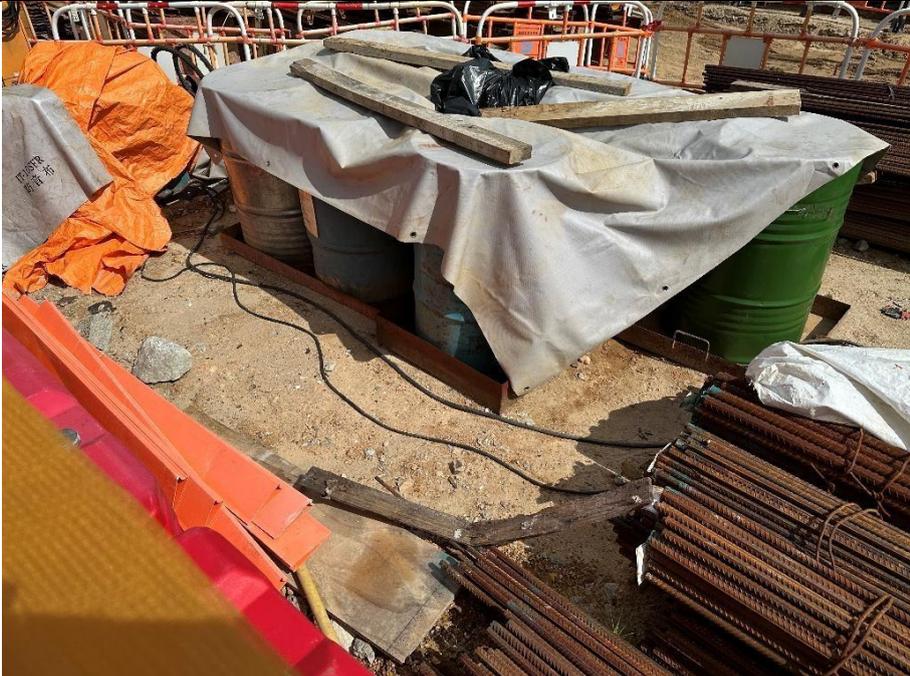
<p data-bbox="400 1760 1374 1794">Figure 1: Proper storage of diesel drum on 15 September 2025 (before the complaint)</p>

Site inspection record was checked. Oil drums stored on site were found to be properly stored on drip trays, and no leakage was observed. The photo of the oil drums is given in **Figure 1** in Photo Records. Active site locations are given in **Figure 2** in Photo Records.

1. Checking of diesel drums storage conditions during the Contractor's daily site inspections to ensure no leakage observed, and are protected by a drip tray.
2. Regular inspection of fuel lines, seals, and connections for signs of wear or leakage and maintaining a spill containment system (e.g., drip trays or bunds) around the genset to contain any potential fuel leaks.
3. Staff training on chemicals storage, and procedure to response to spillage.
4. Should any chemical spillage occur, promptly report to DSD, ER, ET, and IEC on the incidents, and propose proper response actions.

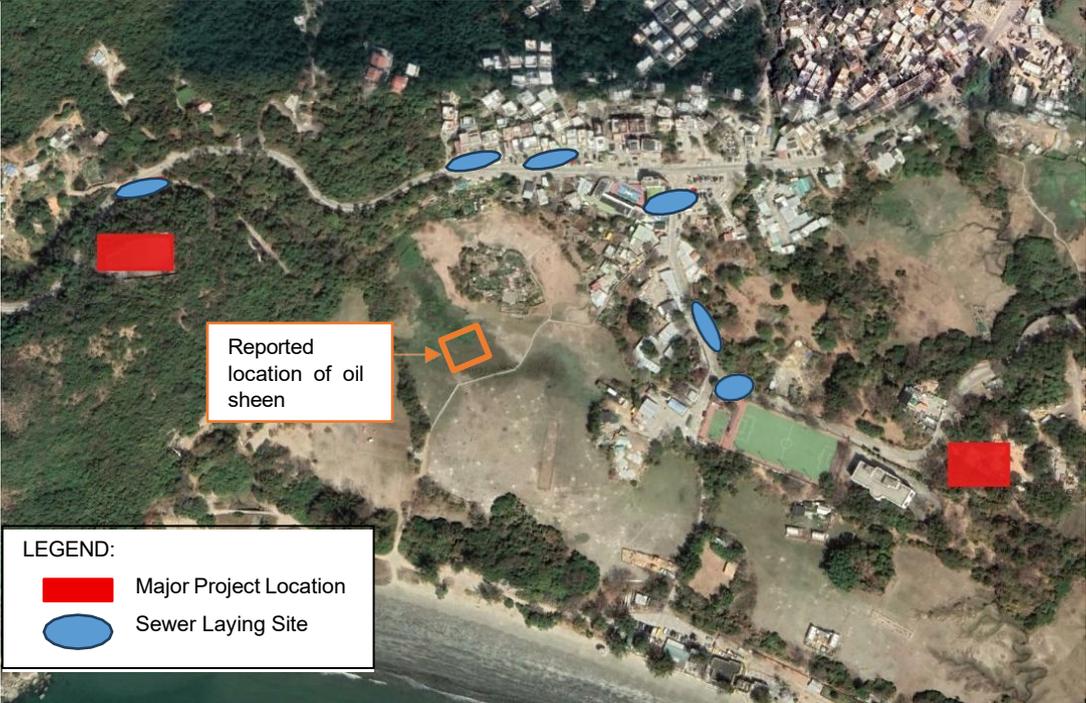
<p data-bbox="555 584 738 674">Reported location of oil sheen</p> <div data-bbox="347 779 719 925"> <p>LEGEND:</p> <ul style="list-style-type: none"> Major Project Location Sewer Laying Site </div> <p data-bbox="719 965 1054 996" style="text-align: center;">Figure 2: Active Site Location</p>
17 September 2025	<p data-bbox="272 1048 1254 1079">ET conducted an unannounced inspection on 17 September 2025. Oil stains were identified.</p>

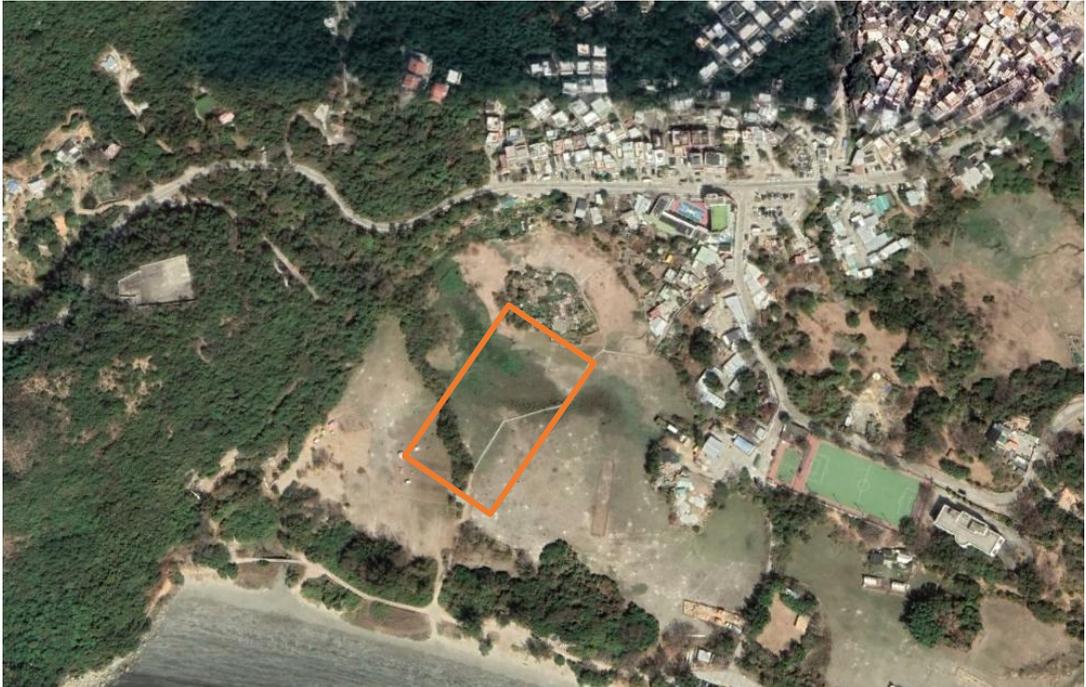
<p data-bbox="719 1787 1054 1818" style="text-align: center;">Figure 3: Inspected locations</p>

On 17 September 2025, an unannounced Inspection was conducted by ET. The inspected locations are given in **Figure 3** in Photo Records. NAPL stains were identified at the wetlands of Pui O. The location of the contamination is shown in **Figure 4** in Photo Records. The Oil stains was observed in the stream (**Figure 5**). The oil sheen was not identified within proximity of our Project Sites.

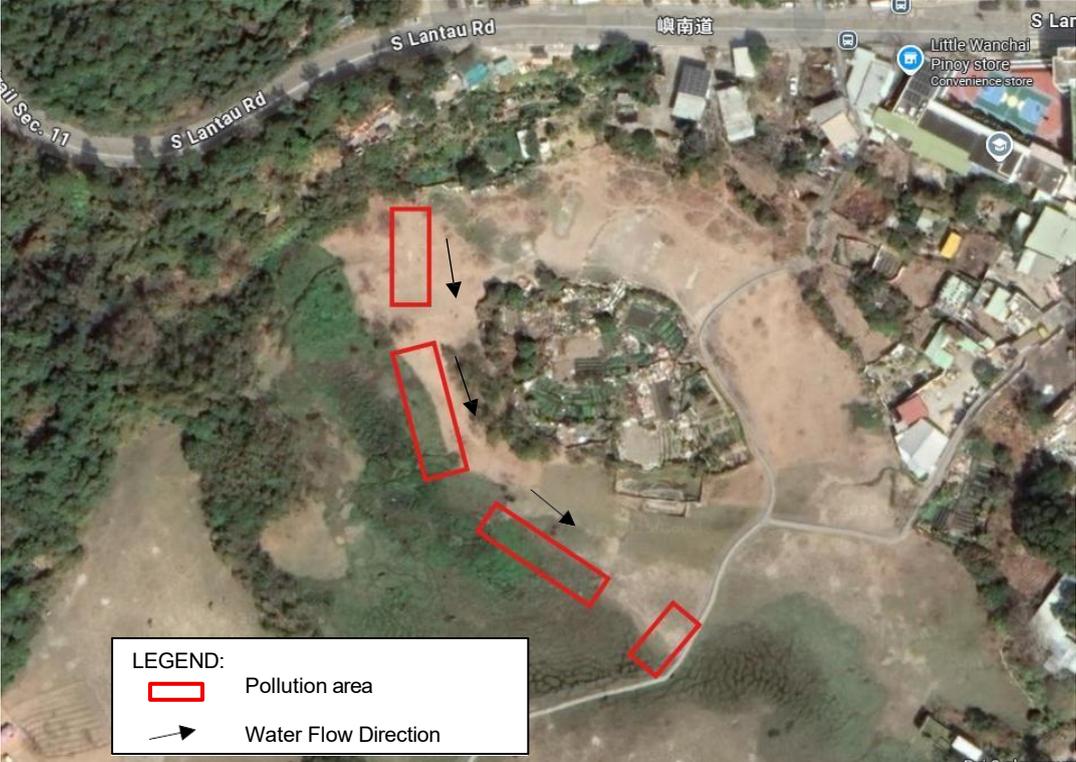
<p style="text-align: center;">Figure 4: The location of the pollution found</p>
<p>17 September 2025</p>

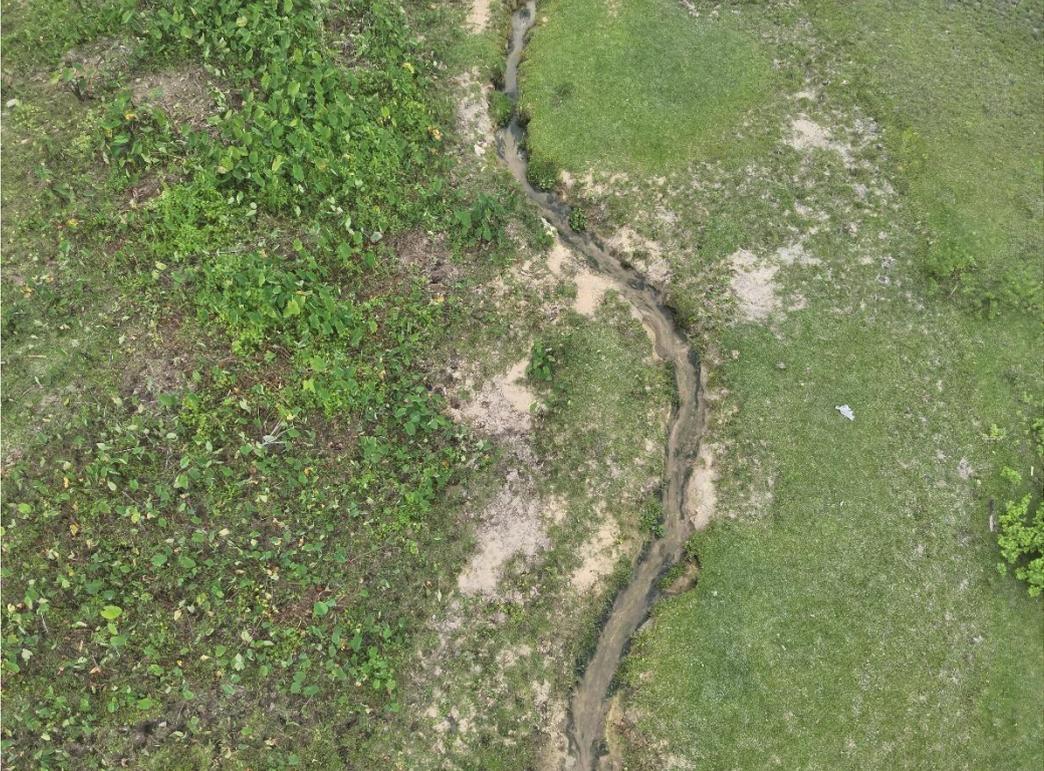
<p style="text-align: center;">Figure 5: Photo on Pollution found in Pui O Wetland</p>

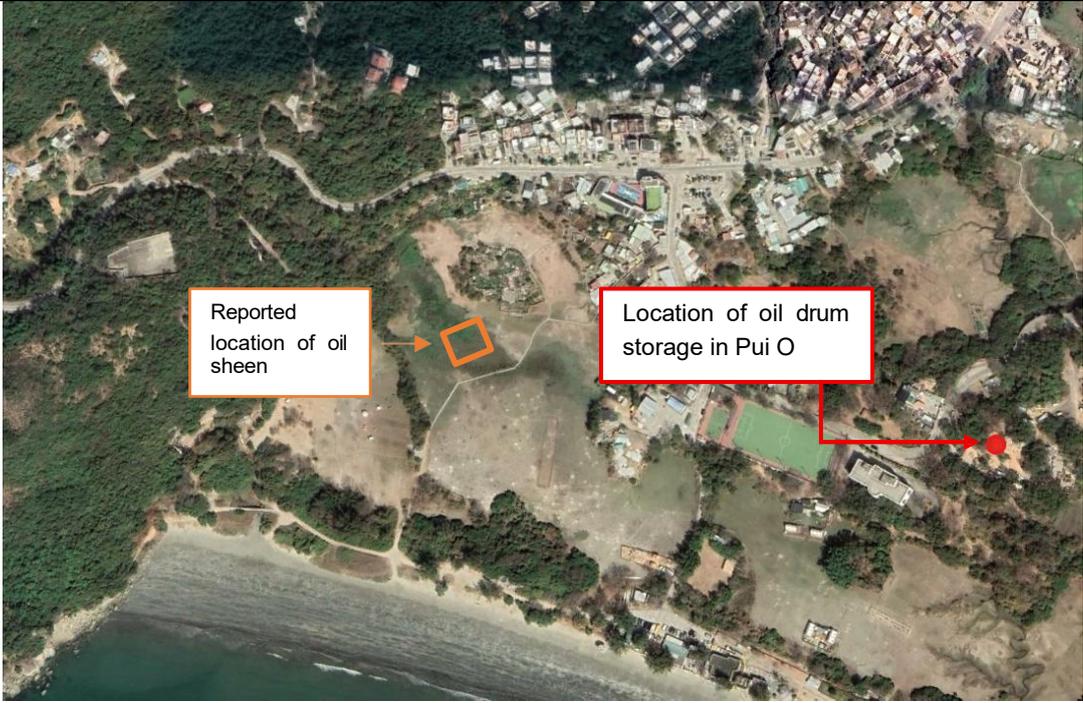
On 18 September 2025, site inspection was conducted by ET and the Contractor on the status of chemical and fuel storage on site. No chemical storage near polluted location was identified (**Figure 6**). In addition, the diesel drum stored on site are in good condition and protected by drip trays. No leakage or spillage was observed (**Figure 7 to 8**).

<p data-bbox="536 546 715 651">Reported location of oil sheen</p> <p data-bbox="948 546 1216 636">Location of oil drum storage in Pui O</p> <p data-bbox="625 969 1155 999">Figure 6: The storage location of the oil drums</p>
<p>18 September 2025</p>	<p data-bbox="276 1043 1445 1072">Diesel fuel drums were stored in a proper manner, and no signs of leakage were detected in the generator set.</p>

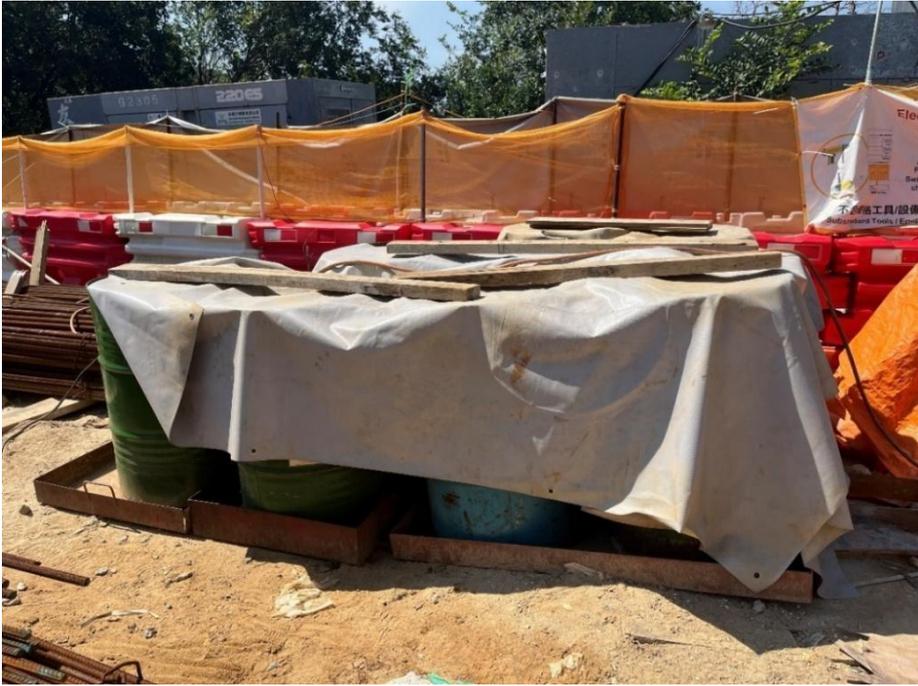
<p data-bbox="536 1771 1246 1800">Figure 7: Proper storage of diesel drum on 18 September 2025</p>

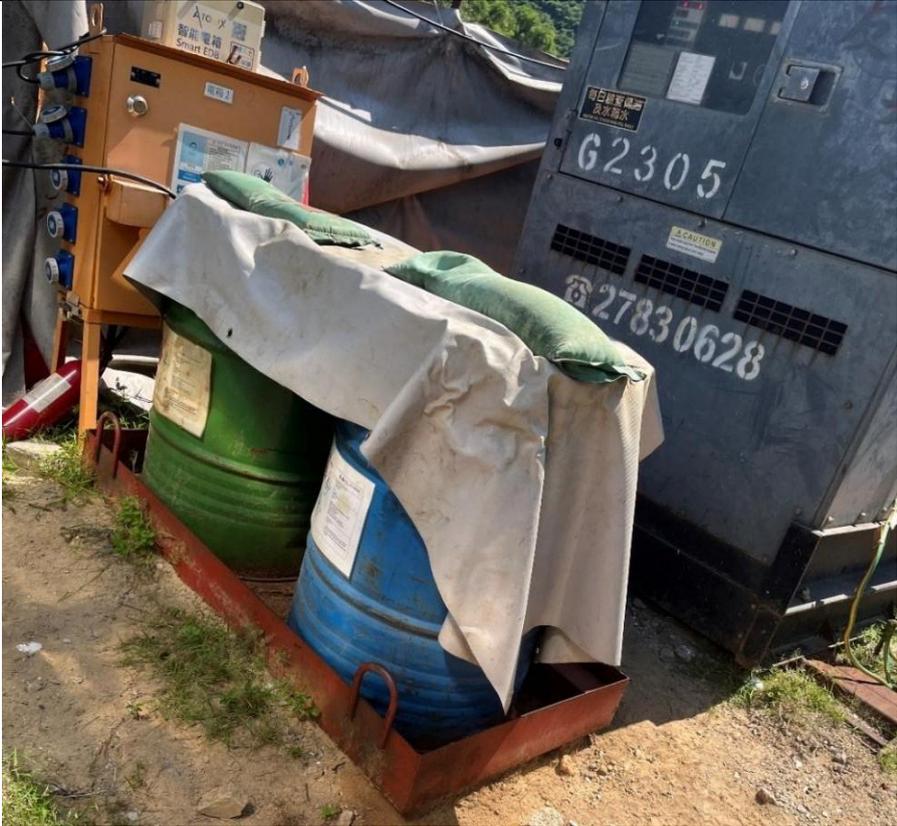
<p style="text-align: center;">Figure 8: Proper storage of diesel drum on 18 September 2025</p>
<p>25 September 2025</p>	<p>On 25 September 2025, a joint inspection was conducted by ET, EPD and Contractor to inspect the location where oil signs were reported by EPD. No source of oil leakage was identified at San Shek Wan Sewerage Treatment Works.</p>

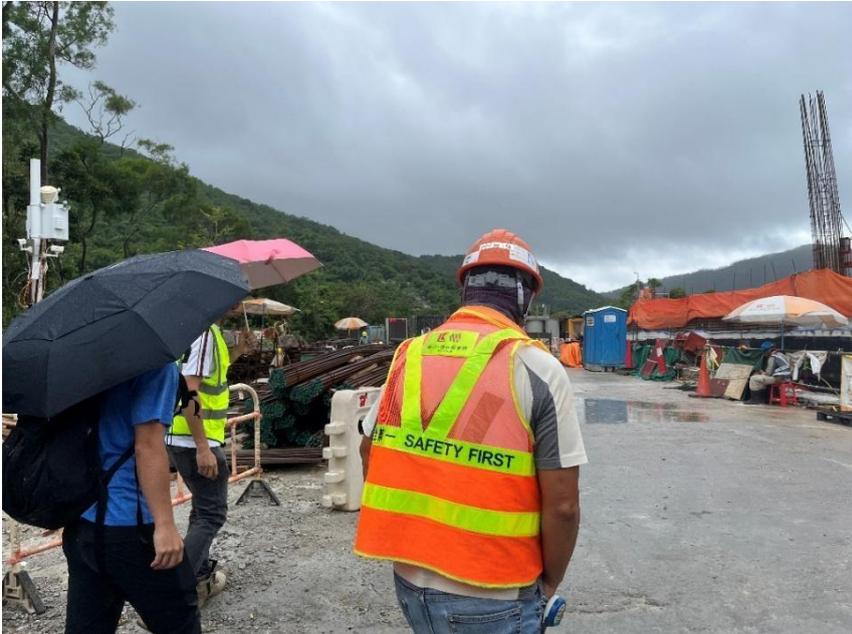
On 25 September 2025, joint site inspection was conducted by ET, EPD, and the Contractor to inspect the location where oil signs were reported by EPD and No oil sheen was found at the location where oil signs were identified as reported by EPD (**Figure 9 to 11**). The joint inspection location was designated by EPD in **Figure 12** in Photo Records. A patch of oil stain was identified during the inspection, and the location is given in **Figure 13** in Photo Records. The location of identified oil stains was not within proximity of the project sites. No source of oil leakage was identified.

<p style="text-align: center;">Figure 9: Photos of the joint site investigation conducted by ET, EPD, and the Contractor</p>

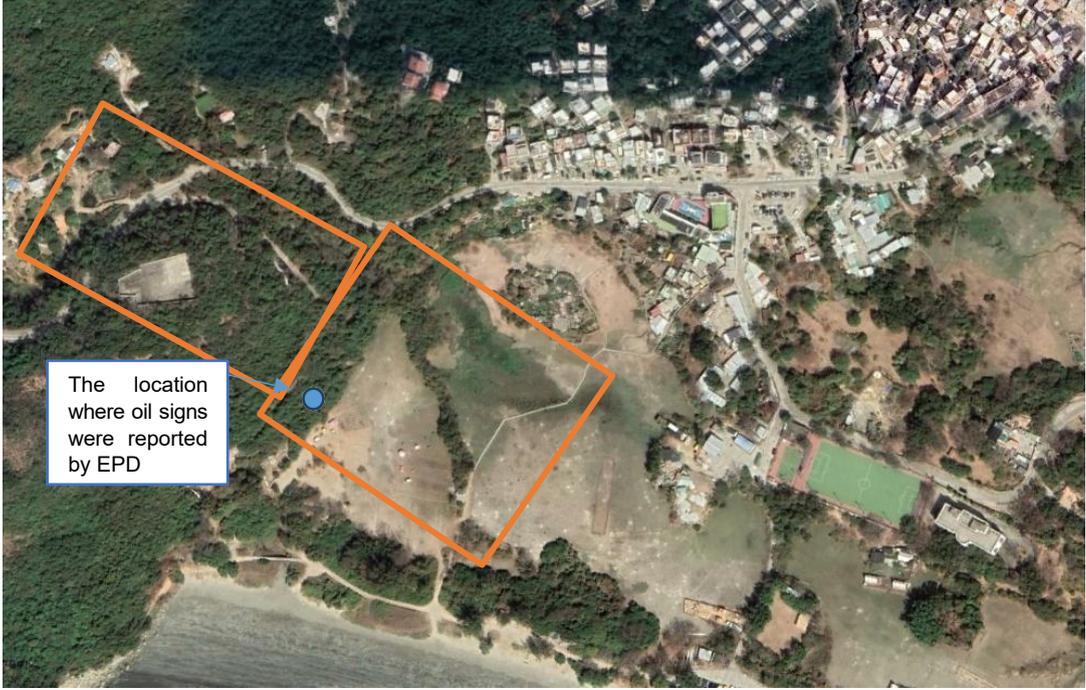
<p style="text-align: center;">Figure 10: Inspected locations</p>
<p>25 September 2025</p>	<p>No oil sheen was found at the location where oil signs were identified as reported by EPD. Its location does not fall within the project site area.</p>

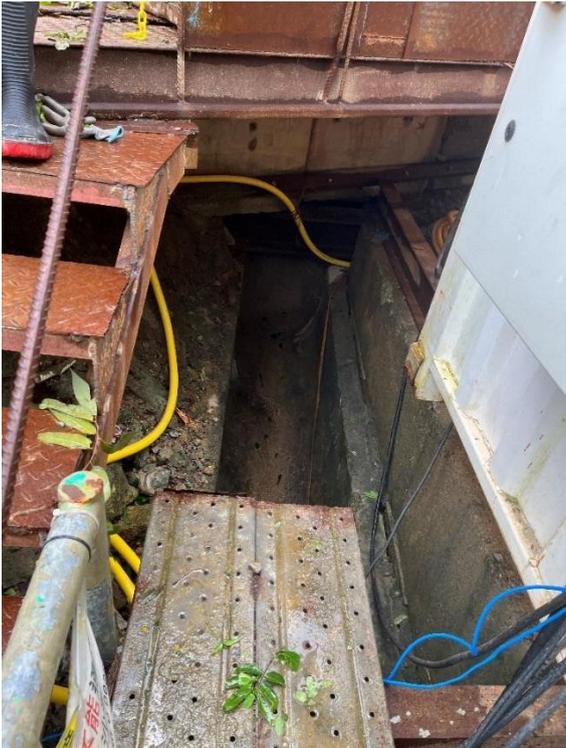
<p style="text-align: center;">Figure 11: The location of oil sheen reported by EPD</p>

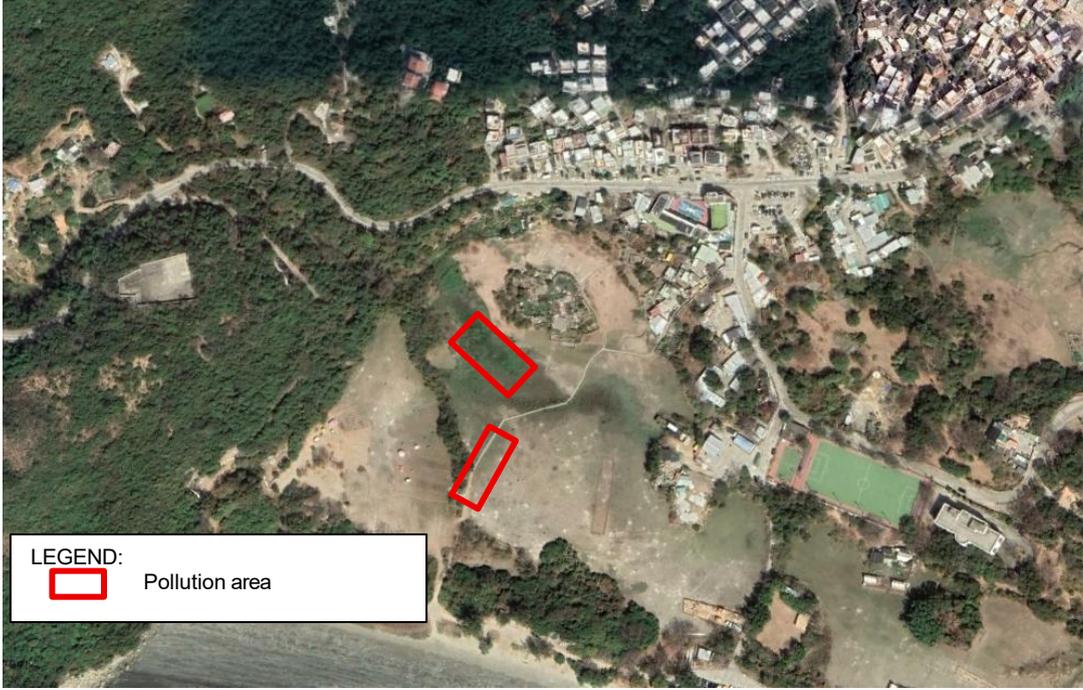
Date	Status / Observation
<p>25 September 2025</p>	<p>Oil signs were identified during the site inspection.</p>

<p style="text-align: center;">Figure 12: The location of the pollution was found</p>
<p>25 September 2025</p>

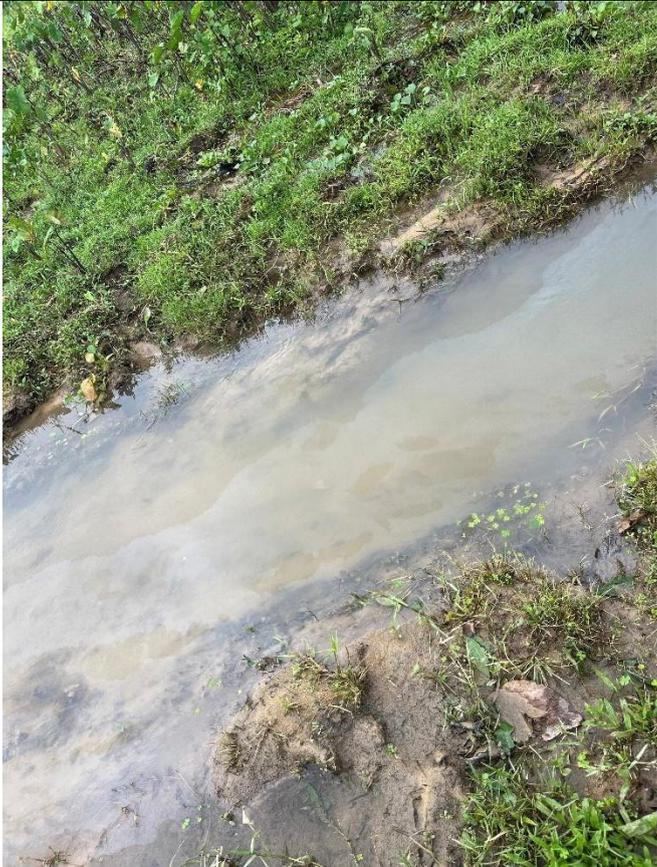
<p style="text-align: center;">Figure 13: Pollution found in Pui O Wetland on 25 September 2025</p>
